## BUILDING INSPECTION & PEST INSPECTION REPORT

11 Mitch Ct  
Somerville, VIC 3912

Jessica Luongo  
19/02/2026

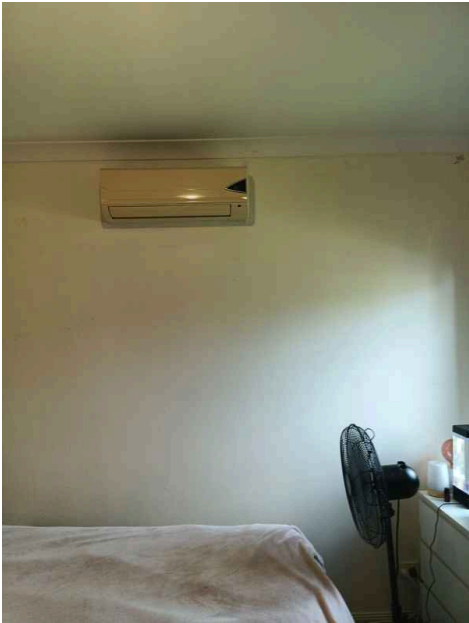
Walls: Air Conditioner General View

Bed2  
Not sure if ac works bed 2

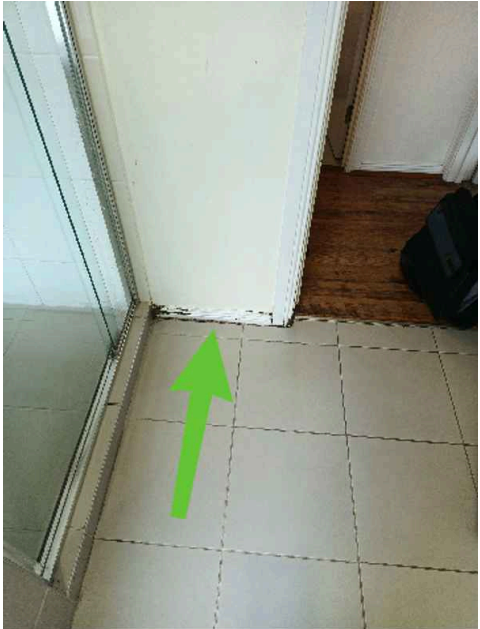
This wall will need to be repaired

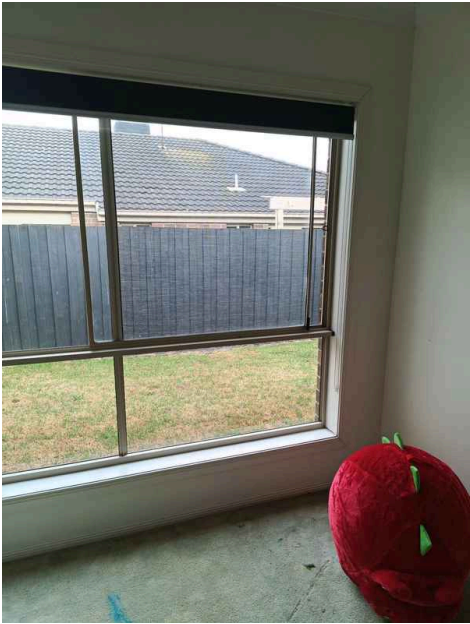
Window(s): Windows general view

Wheels need to be replaced on bottom of window .  
Doesnt open smoothly

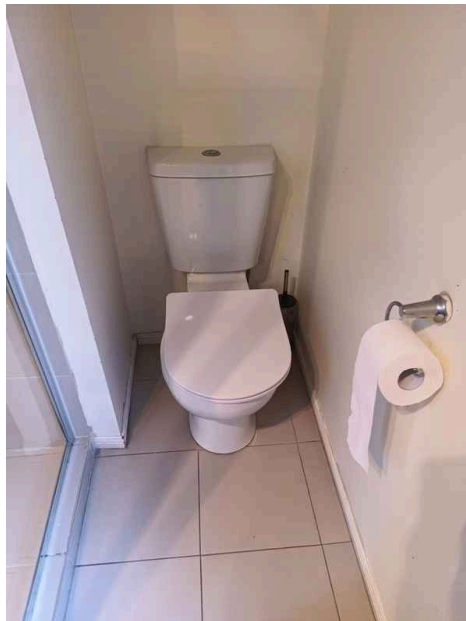
**Toilet: Toilet General View**  
ensuite  
need to replace toilet seat

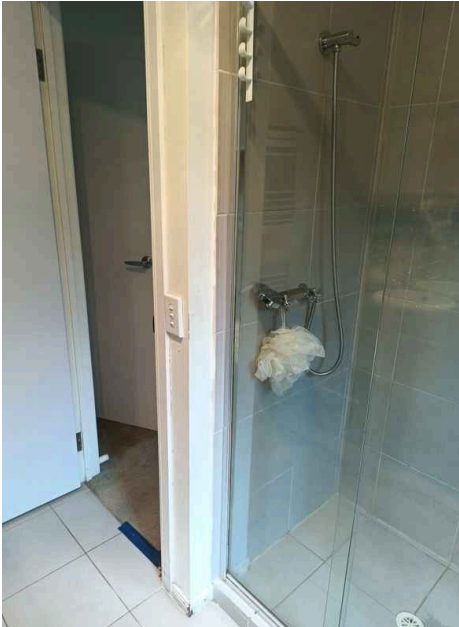
**Walls: Walls General View**

plaster cracks

nib wall beside shower is cracking probably caused by water damage from shower leak

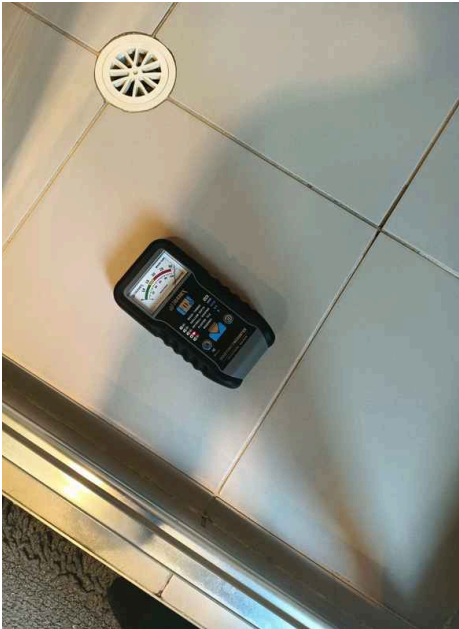
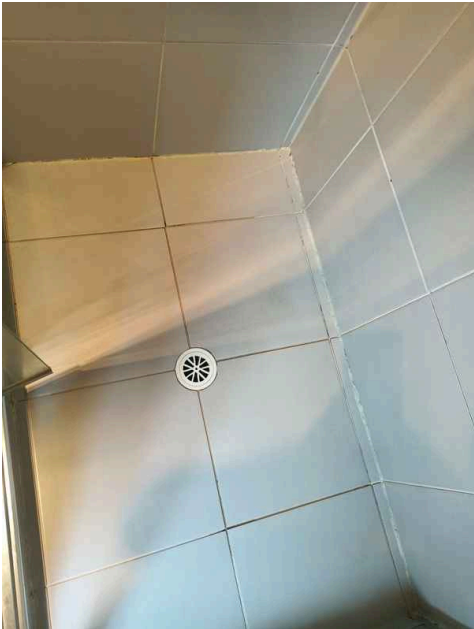
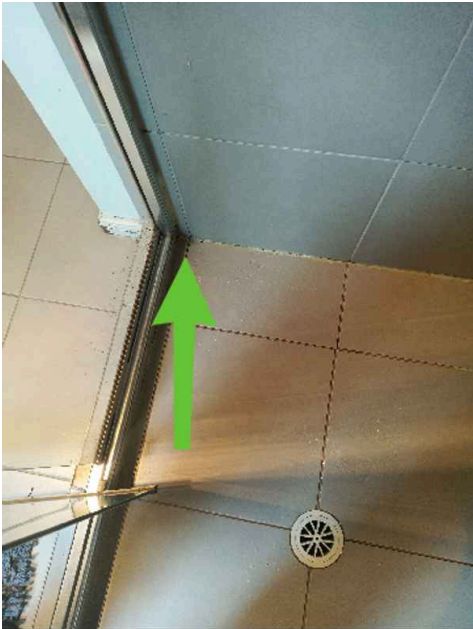
Shower & Bath: Shower Base

shower

cracked tile in shower base with visible gap

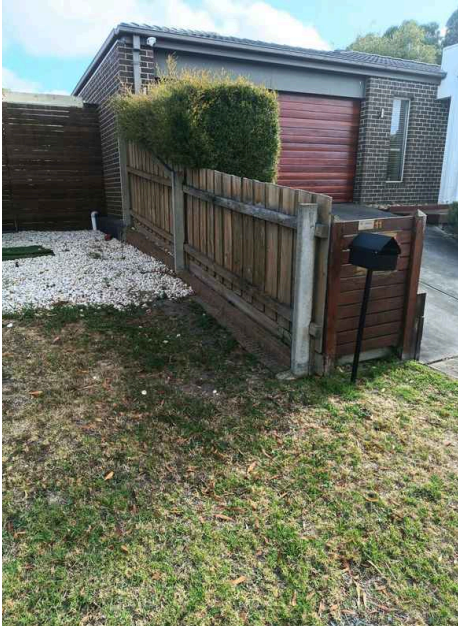
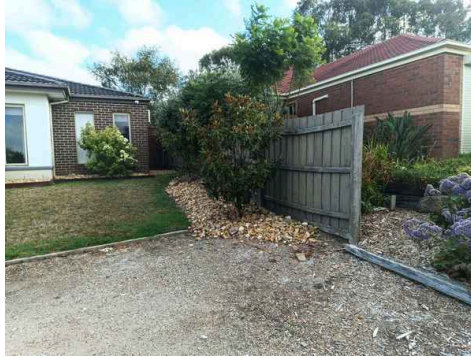
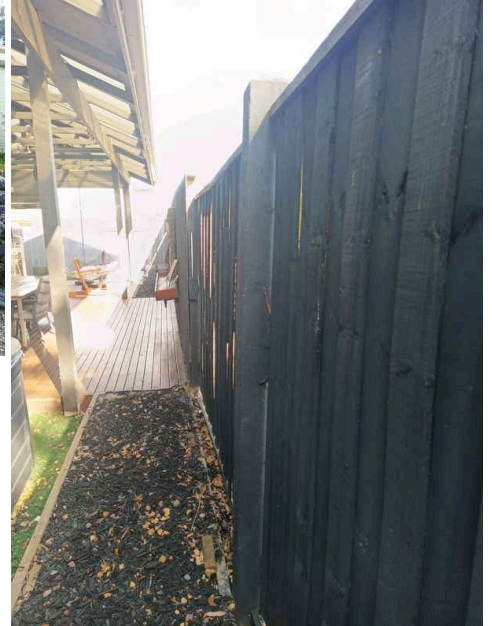
front boundary fence

The front boundary fences both sides will need replacing soon . The fence rails are near the end of there life

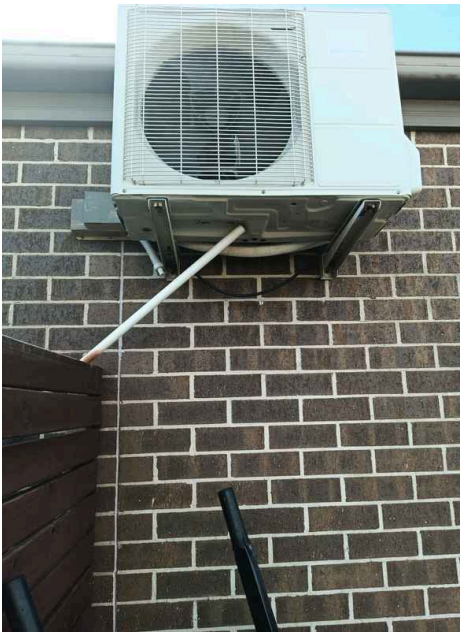
Water Leaks

Air con unit leak

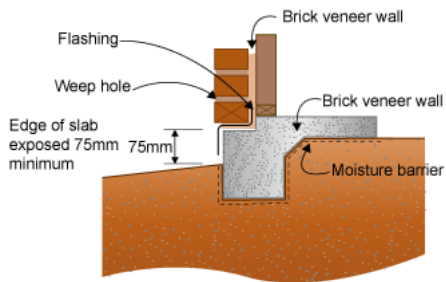
Is the slab edge exposed - No

The slab edge is **not exposed in areas** and should be exposed to a minimum of 75mm around the entire slab edge of the dwelling, in line with current building standards. There is a high risk of concealed termite entry, as it is impossible to ascertain termite entry if the concrete slab edge is not exposed. Termite entry and damage may exist, and we cannot be held liable for poor construction practices.

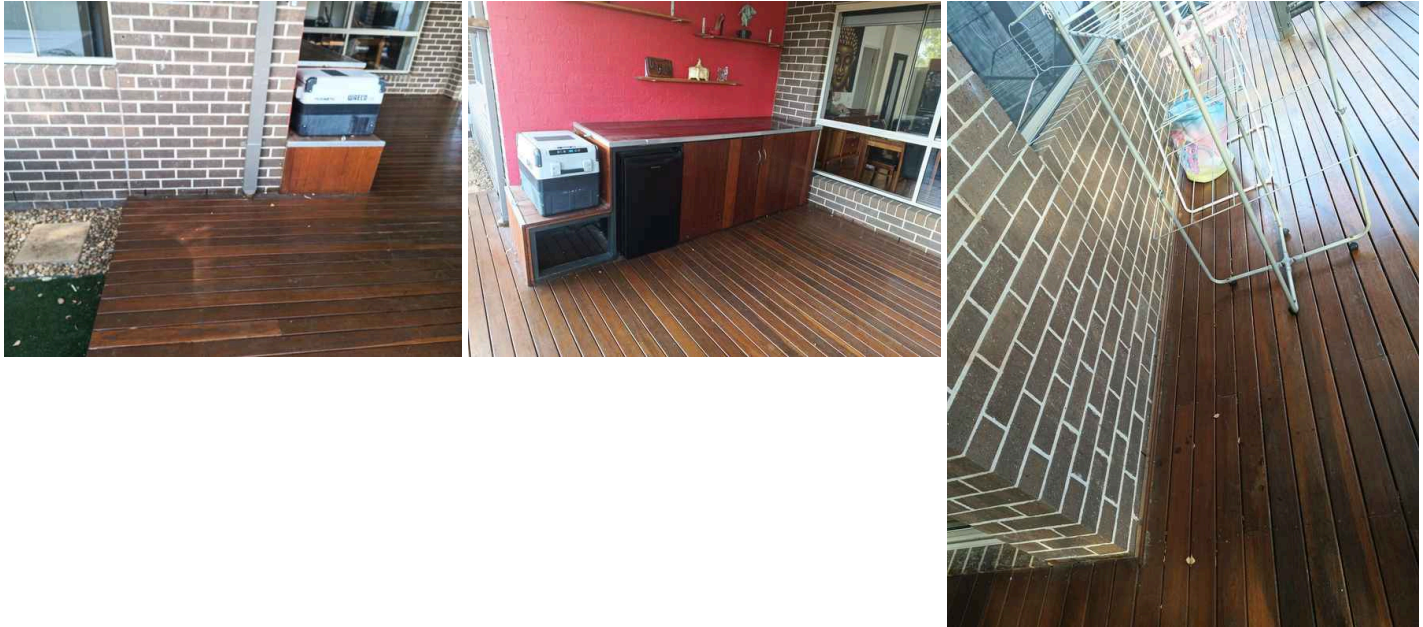
#### Were the weep holes & or Air vents clear of debris

Weepholes partially covered

Obstructed weep holes & vents can allow termites to enter undetected. It is always recommended to keep these unobstructed to increase ventilation and limit termite access.
