## BUILDING INSPECTION & PEST INSPECTION REPORT

11 Mitch Ct  
Somerville, VIC 3912

Jessica Luongo  
19/02/2026

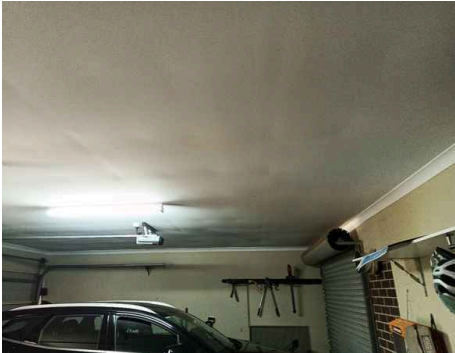
Ceiling Lining Condition: Ceiling General View  
General wear and tear noted
