## BUILDING INSPECTION & PEST INSPECTION REPORT

11 Mitch Ct  
Somerville, VIC 3912

Jessica Luongo  
19/02/2026

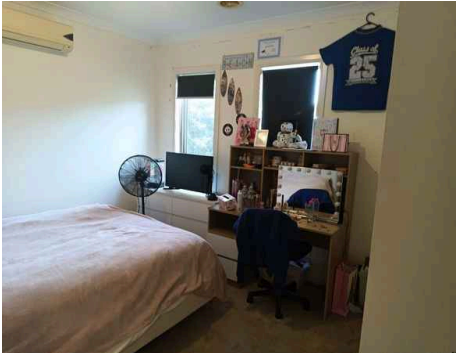
Walls: Air Conditioner General View

Bed2  
Not sure if ac works bed 2

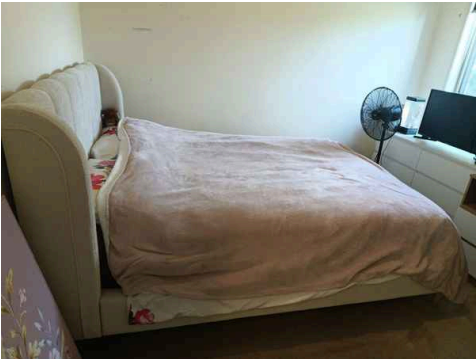
5.3.1 Walls

MAINTENANCE/ MONITOR

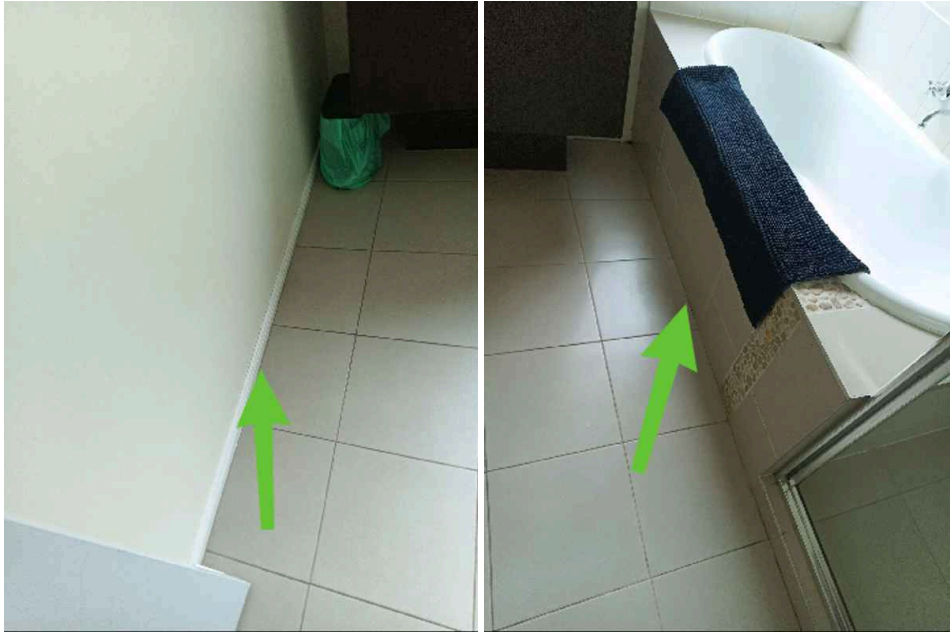
## 6.8.1 Shower &amp; Bath

**MOISTURE READING HIGH AROUND/BELOW SHOWER TAPS**

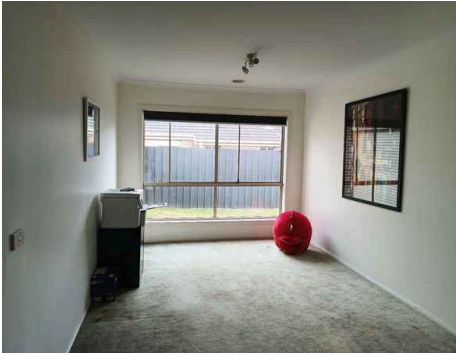
Window(s): Windows general view

Wheels need to be replaced on bottom of window .  
Doesnt open smoothly

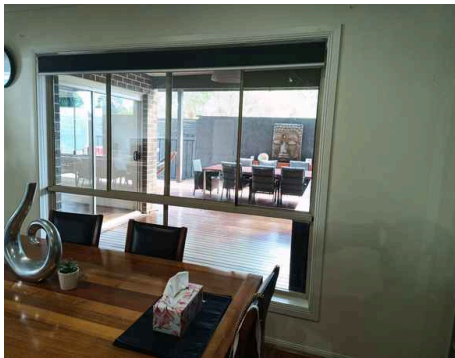
Meals area

wheels need replacing very difficult to open

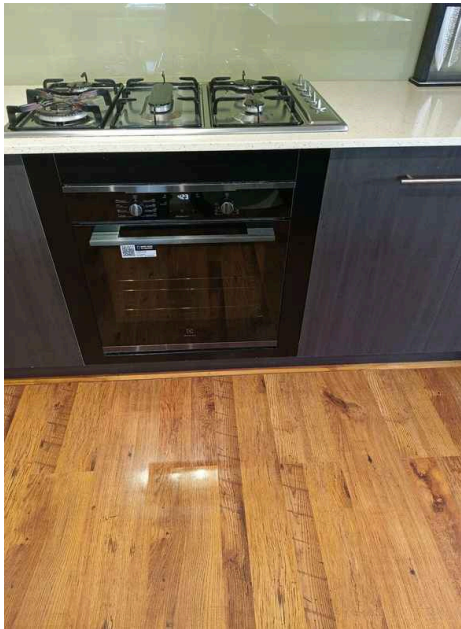
Sink, Cabinetry & Benchtops: Bench top/s  
bench tops kitchen

Kitchen bench top needs to be caulked around the splash back perimeter

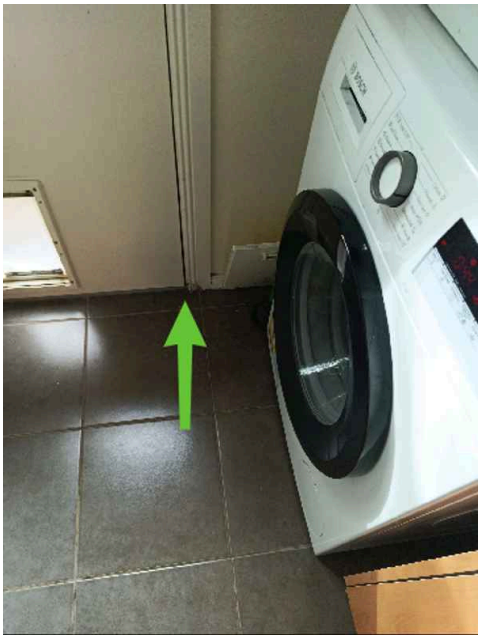
AGE/DETERIORATION

Age/deterioration noted to door. Consider budgeting to have replaced.

Contact a qualified carpenter.

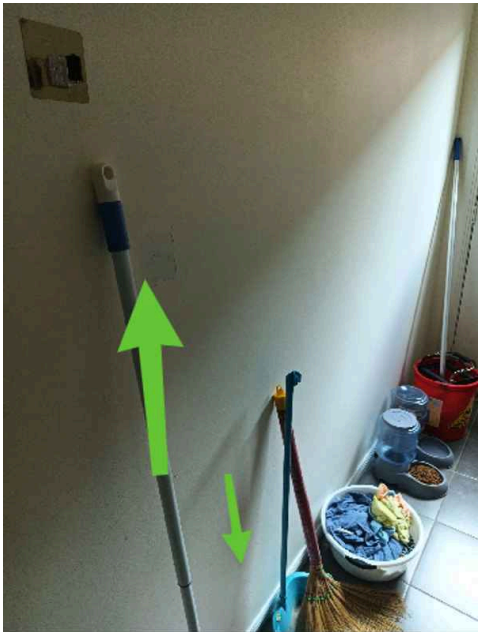
12.3.1 Walls

AGE/DETERIORATION

General aging and/or denting and/or wear and/or previous wall patching and the like is evident on wall linings - Recommendations: A qualified painter should be engaged to assess and repair as required.

Contact a qualified painting contractor.

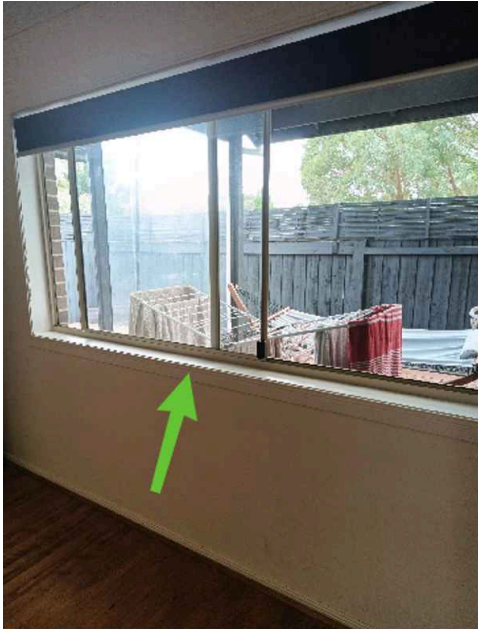
14.4.1 Walls

WALL SURFACE WEAR

Normal age-related wear on walls represents typical deterioration over time. Surface shows general aging consistent with property usage.

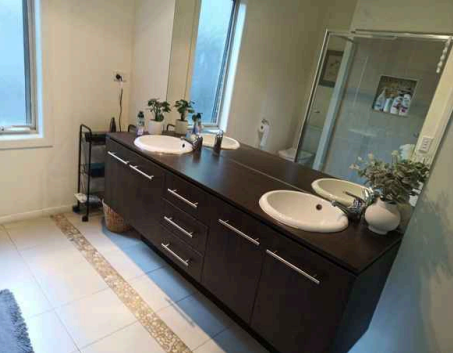
Ensuite: General View

basins  
No plug washer in either basins

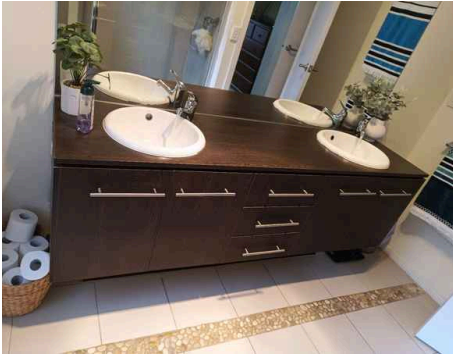
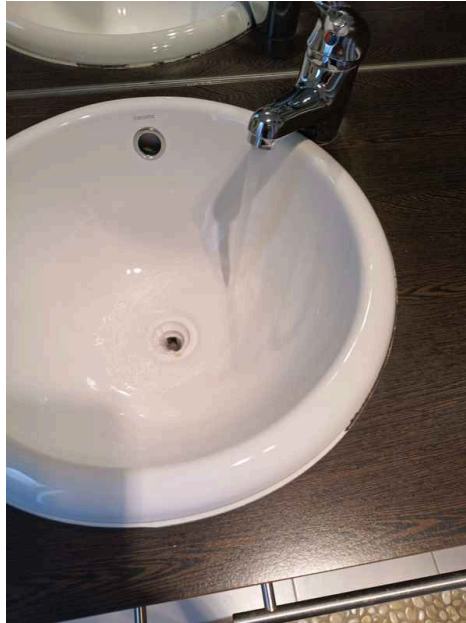
Vanity / Cabinetry Taps/Basin: Trap Waste Water - under sink

Water was actively running during visual inspection of the waste trap.

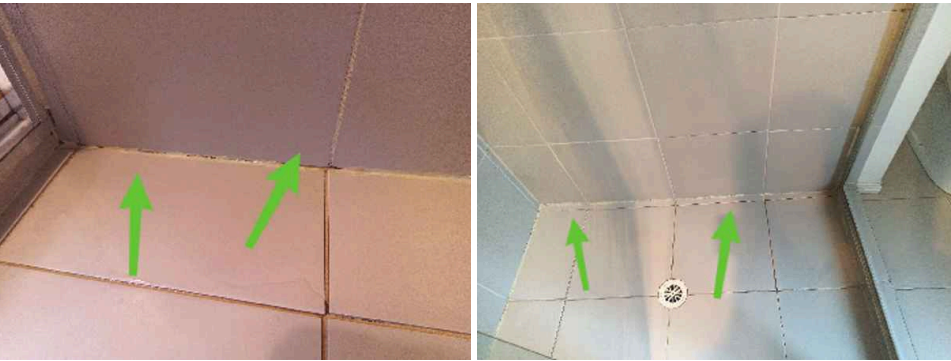
15.8.1 Shower & Bath

CRACKED TILES

Tile damage observed in shower/bath area. Cracking can lead to water penetration and potential underlying surface damage. Recommend professional tile repair to prevent further deterioration.

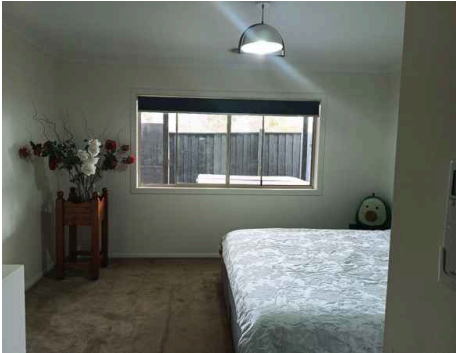
Window(s): Windows general view

main bedroom

Window is very difficult to open . Rollers need replacing

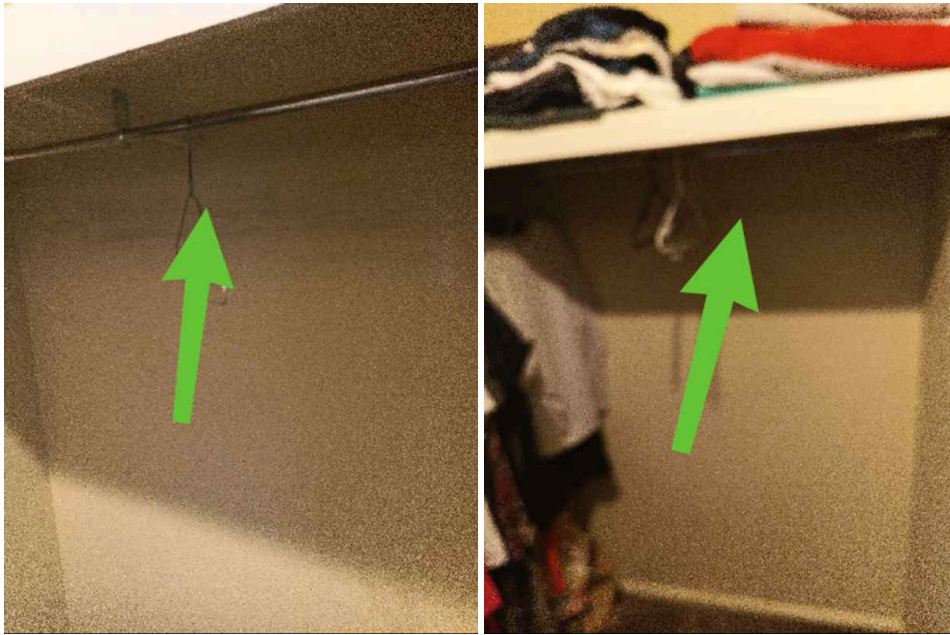
**COSMETIC MARKS OBSERVED**

Cosmetic marks were observed. These do not affect function but may impact presentation.

Contact a qualified professional.

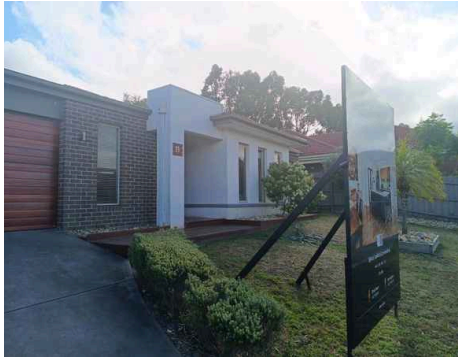
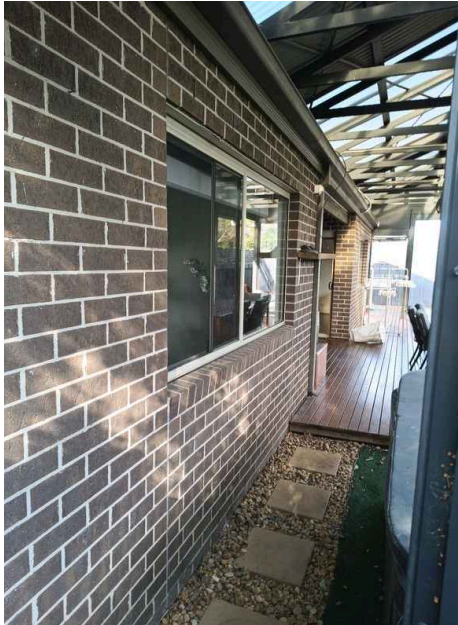
weep holes are covered by the rear deck . Not good for termite inspection

air con condensation lines are discharging onto ground . They need to be connected to stormwater outlet or place bucket under condensation line and empty

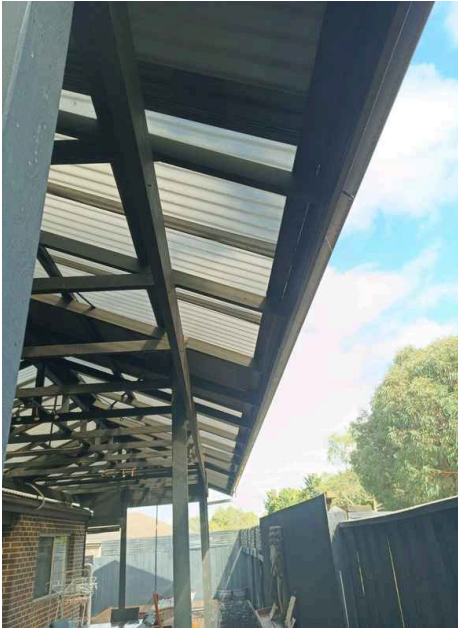
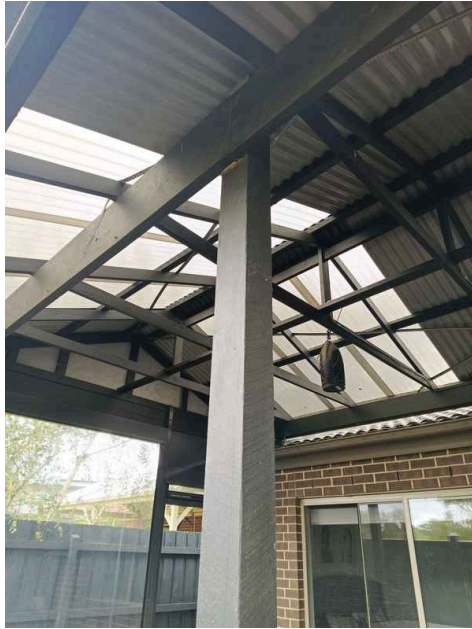
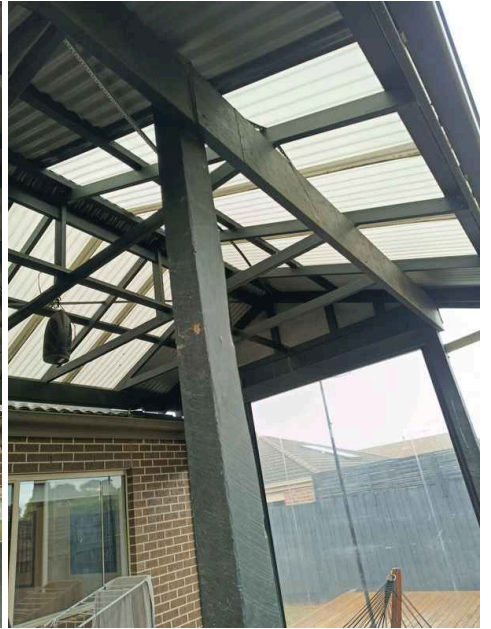
Rear verandah beams aren't Checked into the Posts and are fastened using bugle screws .

The verandah beam for a beam of that size should have 3 x bolts in each end of the beam to post connection .

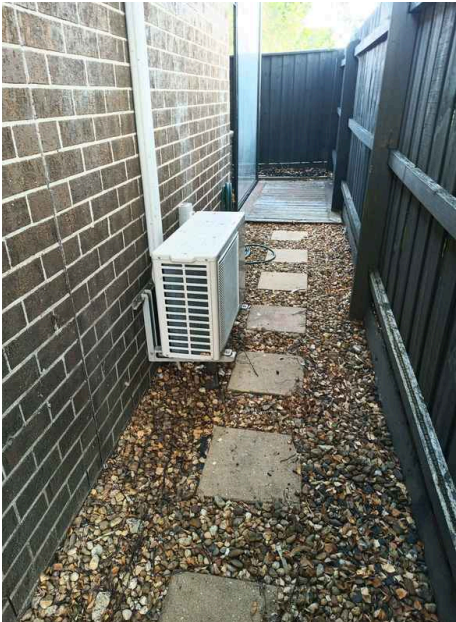
Air con unit leak

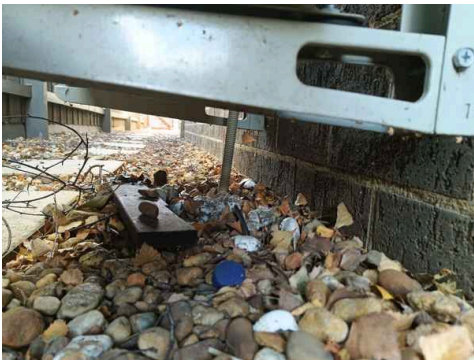
Is the slab edge exposed - No

The slab edge is **not exposed in areas** and should be exposed to a minimum of 75mm around the entire slab edge of the dwelling, in line with current building standards. There is a high risk of concealed termite entry, as it is impossible to ascertain termite entry if the concrete slab edge is not exposed. Termite entry and damage may exist, and we cannot be held liable for poor construction practices.

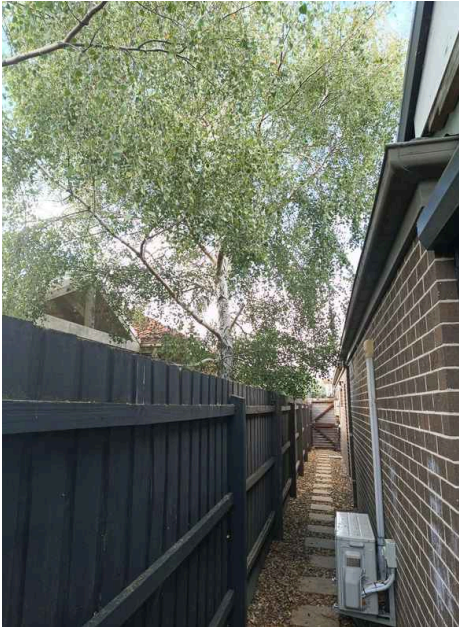
Trees close to the dwelling and within the termite foraging area create favourable conditions for termite infestation. I recommend coordinating with your neighbours to have these trees regularly inspected and, if they are on your property, arranging regular inspections for termite activity.
